SWTEST

2024 CONFERENCE

Risk Mitigation Strategies for mmWave Production Test Environments

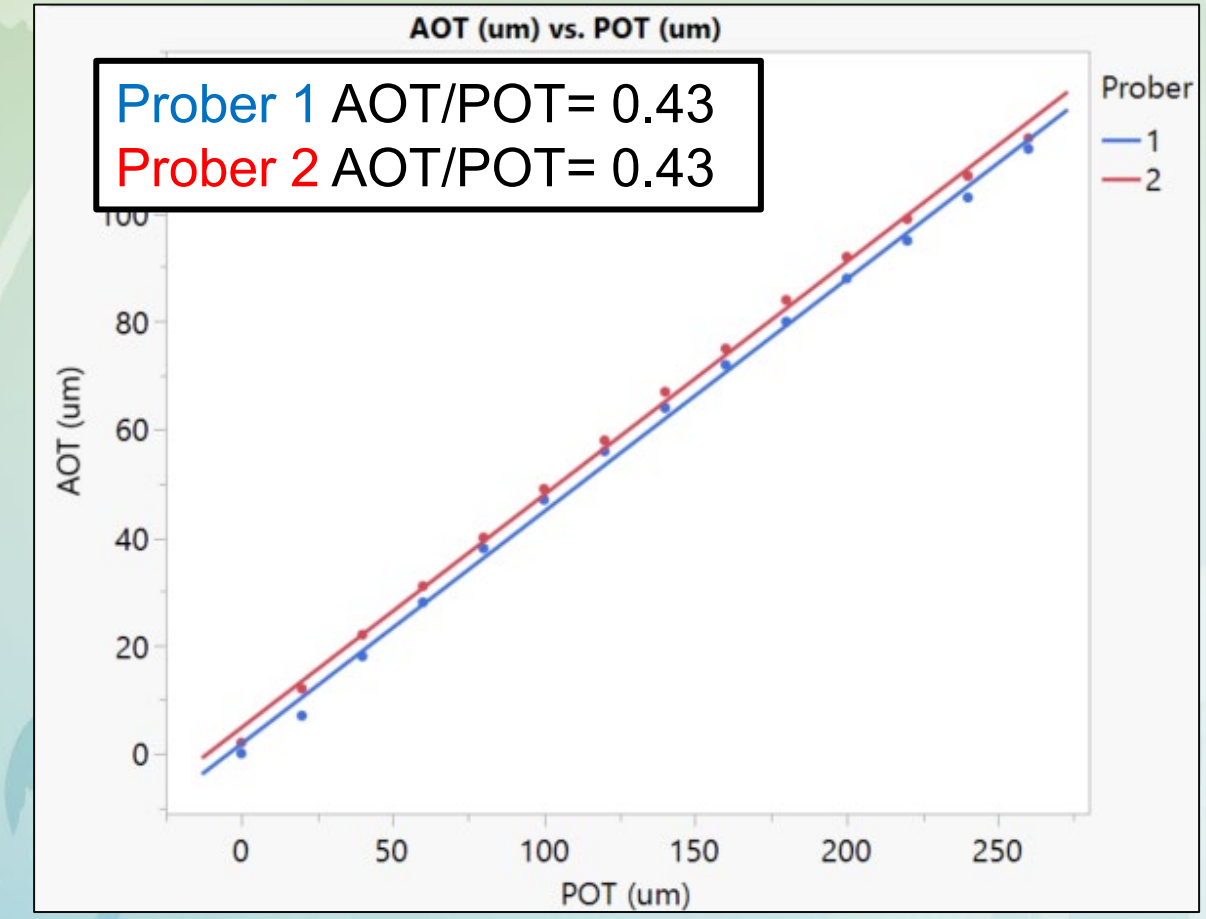
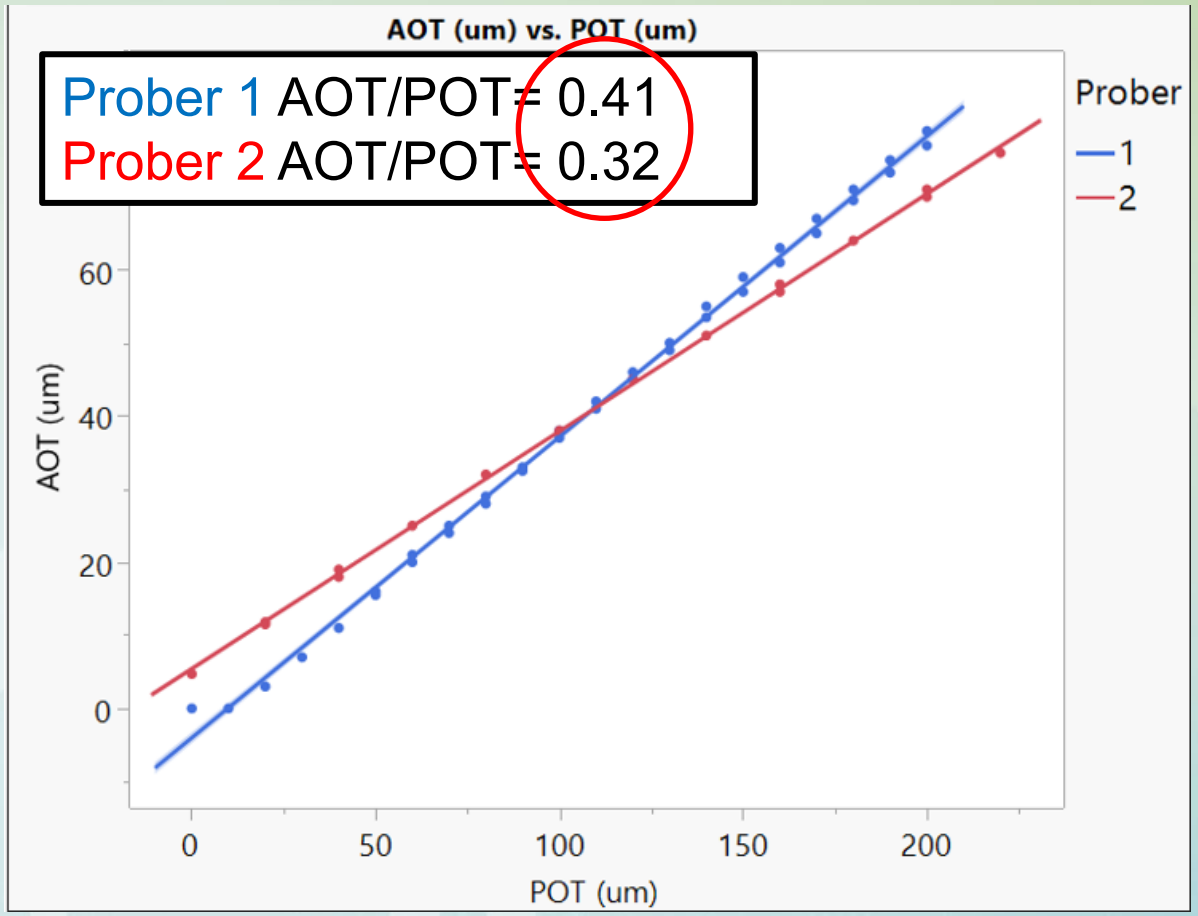
AOT/POT Variation by Prober

- ~20% difference in AOT/POT between probers at customer #2

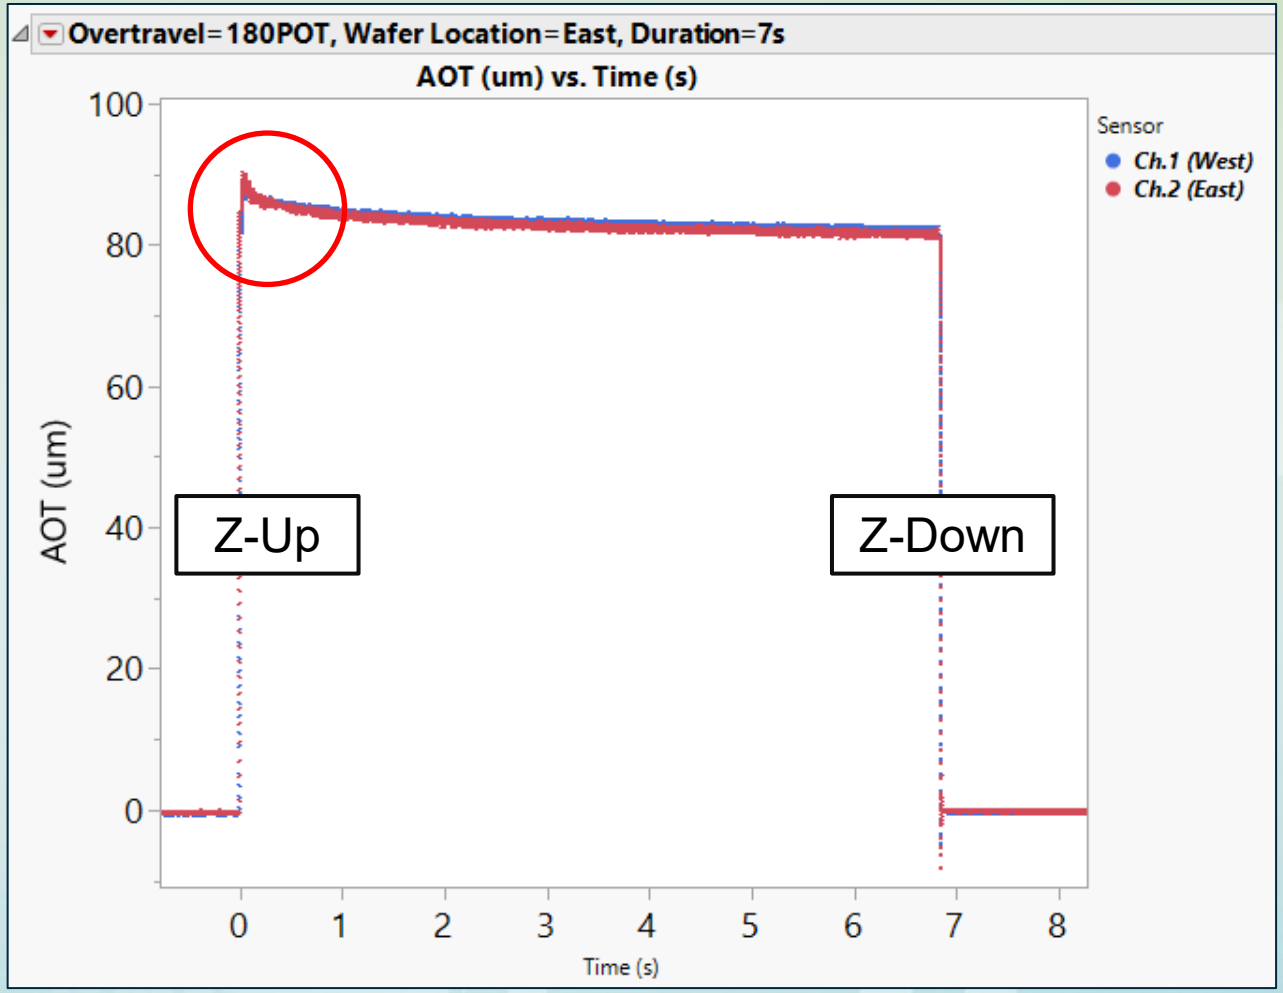
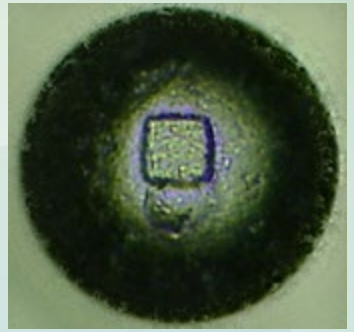
AOT vs Time on Solder Bump

- Reduction in AOT after prober Zup is due to probe tips penetrating into solder bump.
- Sensor data helps to quantify transient response of tip penetration into solder

Probe mark in solder bump

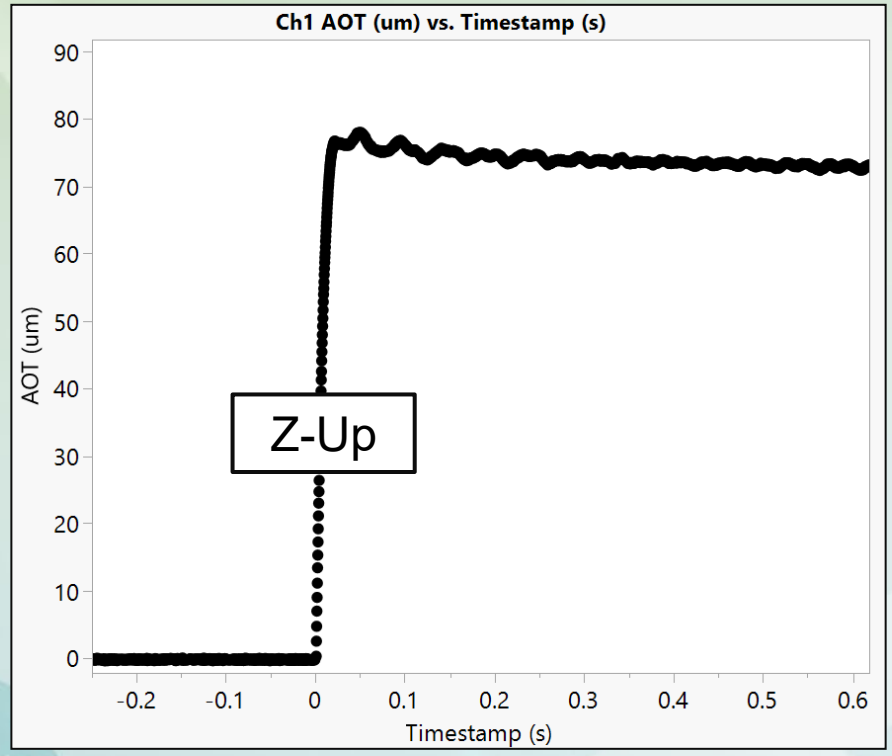
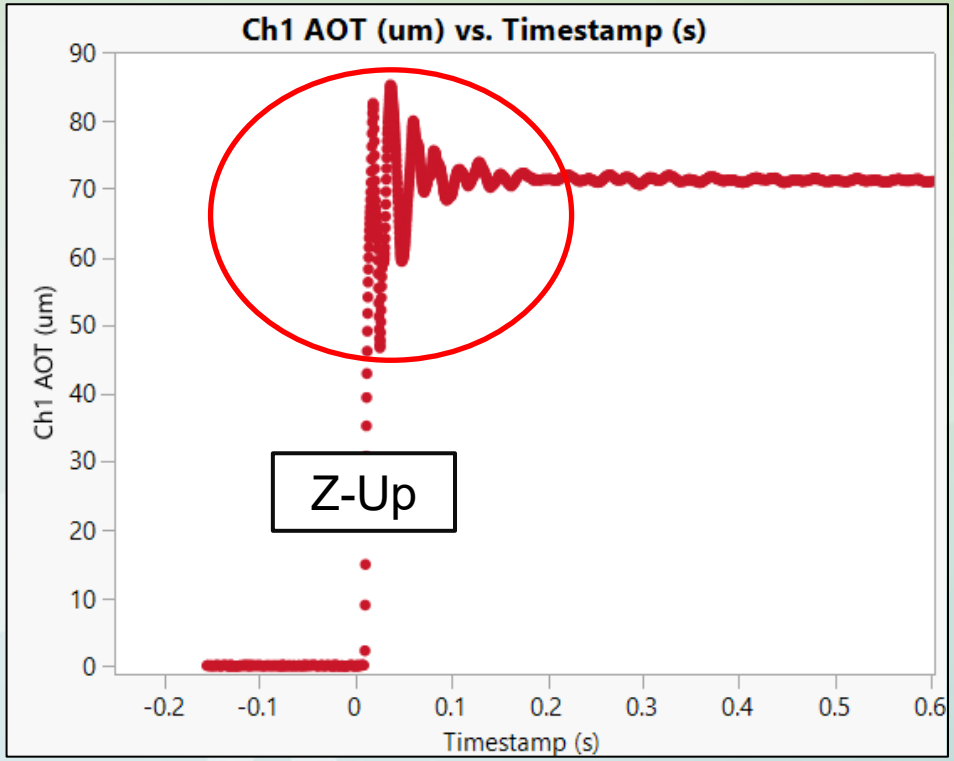
Prober Bounce

- Undesirable transient oscillation observed at Customer #2
- Root cause was due to incorrect deceleration settings on prober
  - Customer delighted issue was discovered and resolved

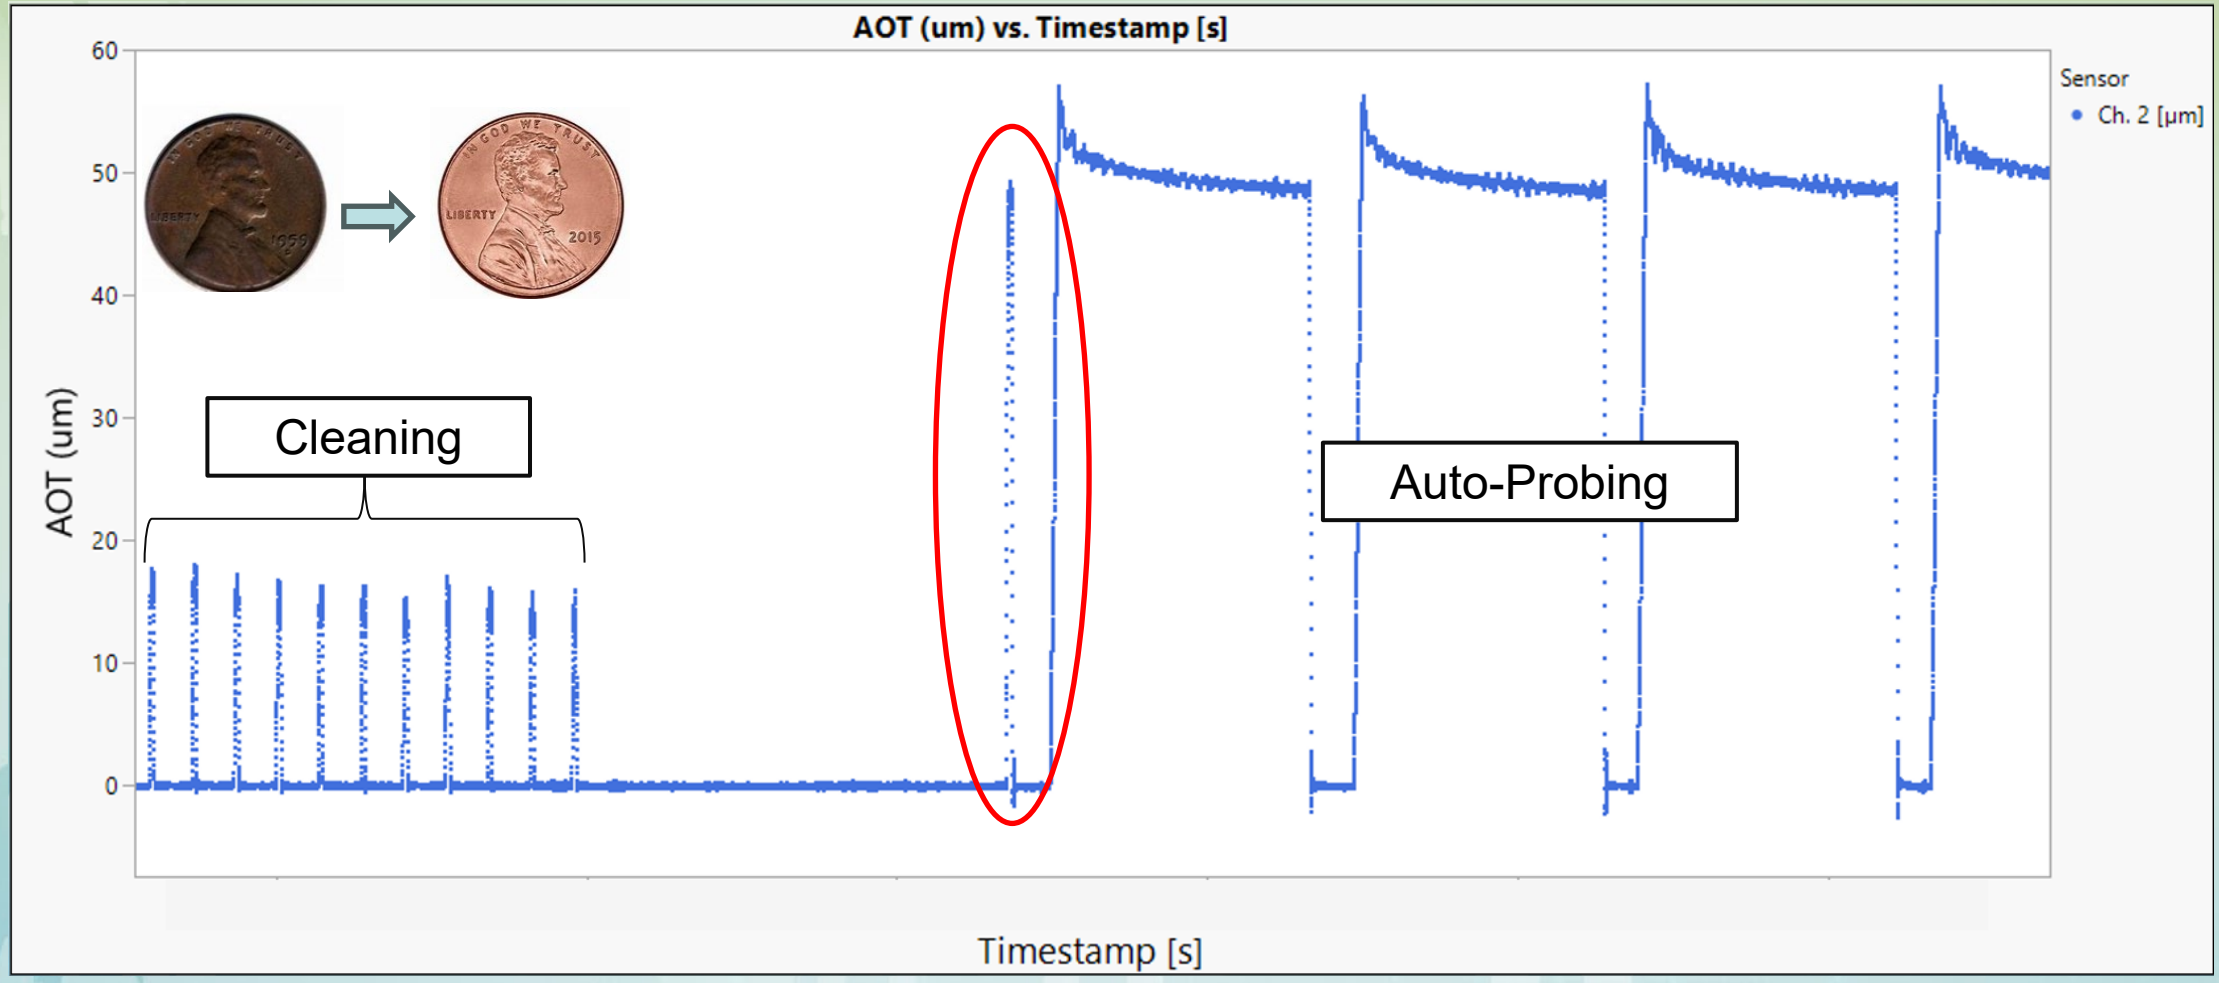
Z-up Mystery

- Strange short duration Z-up observed after cleaning
- Root Cause: Prober setting →Return to previous position after cleaning
  - Undesirable setting as 1st TD after cleaning is made on a previously probed die.
- Prober setting changed to→ Go to next die after cleaning

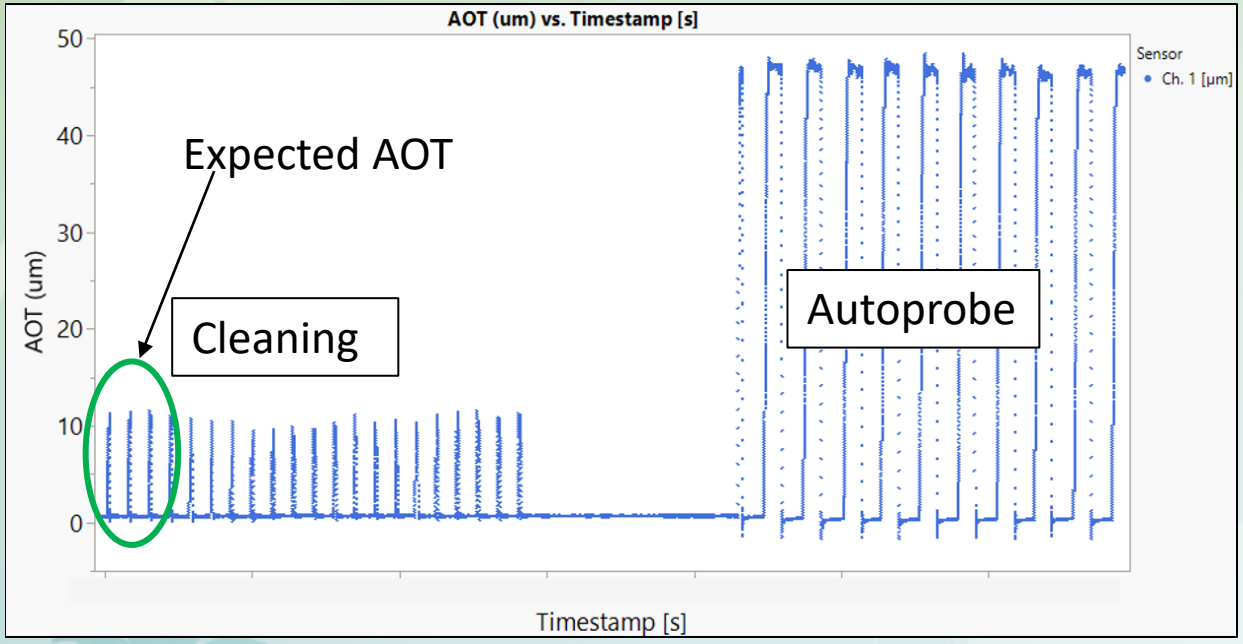
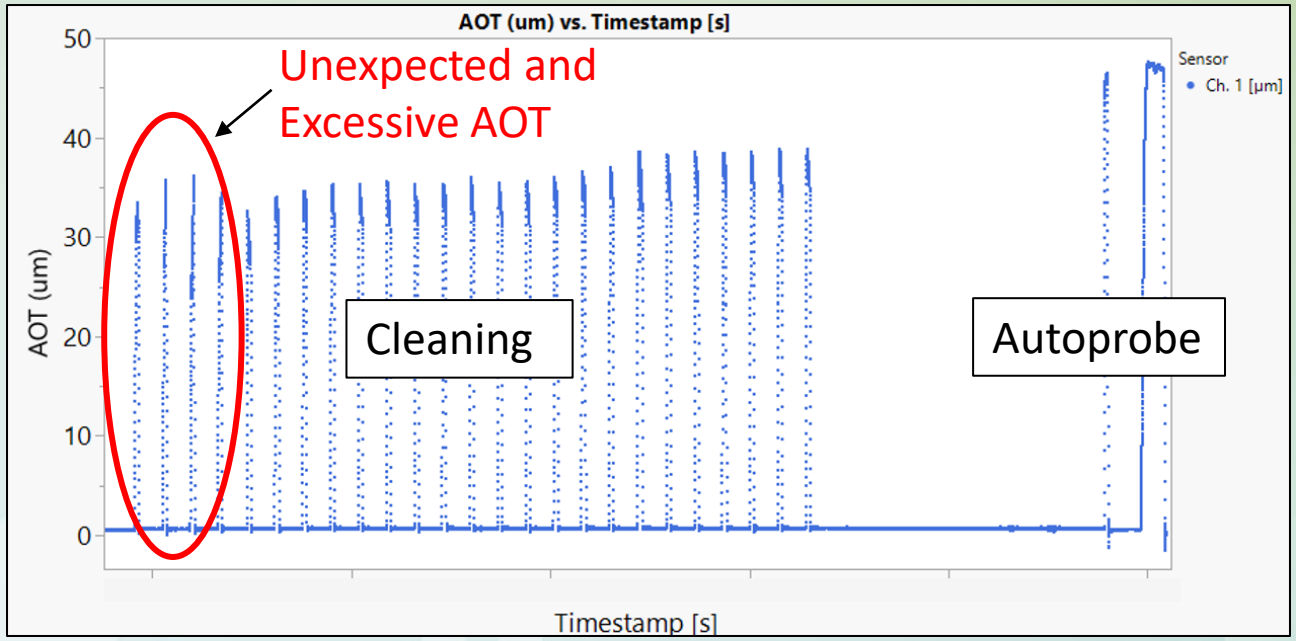
Cleaning Concerns

- Unexpected shift in cleaning AOT measured at customer site.
  - Both events captured during <u>one continuous test</u>
- At a minimum, excessive cleaning AOT observed will reduce lifetime
- Leading suspect is cleaning plate not parallel to headplate
